Geounit ID: <u>5730</u>	Property ID (AD#): <u>AD-000686</u>	Address: <u>875 US Highway 2</u>
----------------------------	--	-------------------------------------

Surveyor(s)/Company: M. Farnham (CDM SMITH) Removal Contractor: PRI-ER

US ARMY CORPS OF ENGINEERS OMAHA DISTRICT RAPID RESPONSE PROGRAM</div>	LIBBY ASBESTOS PROJECT LINCOLN COUNTY, MONTANA	AD #: 000686      GEUNIT #: 5730      GRZ #: 00	DRAWING BY/DATE T. ROBERTSON 03/28/13	REVISION #:	REVISION DATE:	DESCRIPTION:
		LINCOLN COUNTY PORT AUTHORITY  875 US HIGHWAY 2  RESTORATION DESIGN	QC REVIEW BY/DATE K. MCKENZIE 04/03/13	0	04/12/13		
			DRAWING FINALIZED BY/DATE T. ROBERTSON 04/12/13	N/A	N/A	N/A	
				N/A	N/A	N/A	
				N/A	N/A	N/A	
...\\OU4\STREET BY NAME\US HIGHWAY 2\875 US HIGHWAY 2\FISHING POND\CAD\--FINAL DESIGN--REV.0.DWG

Property Address: 875 US Hwy 2 (Fishing Pond)

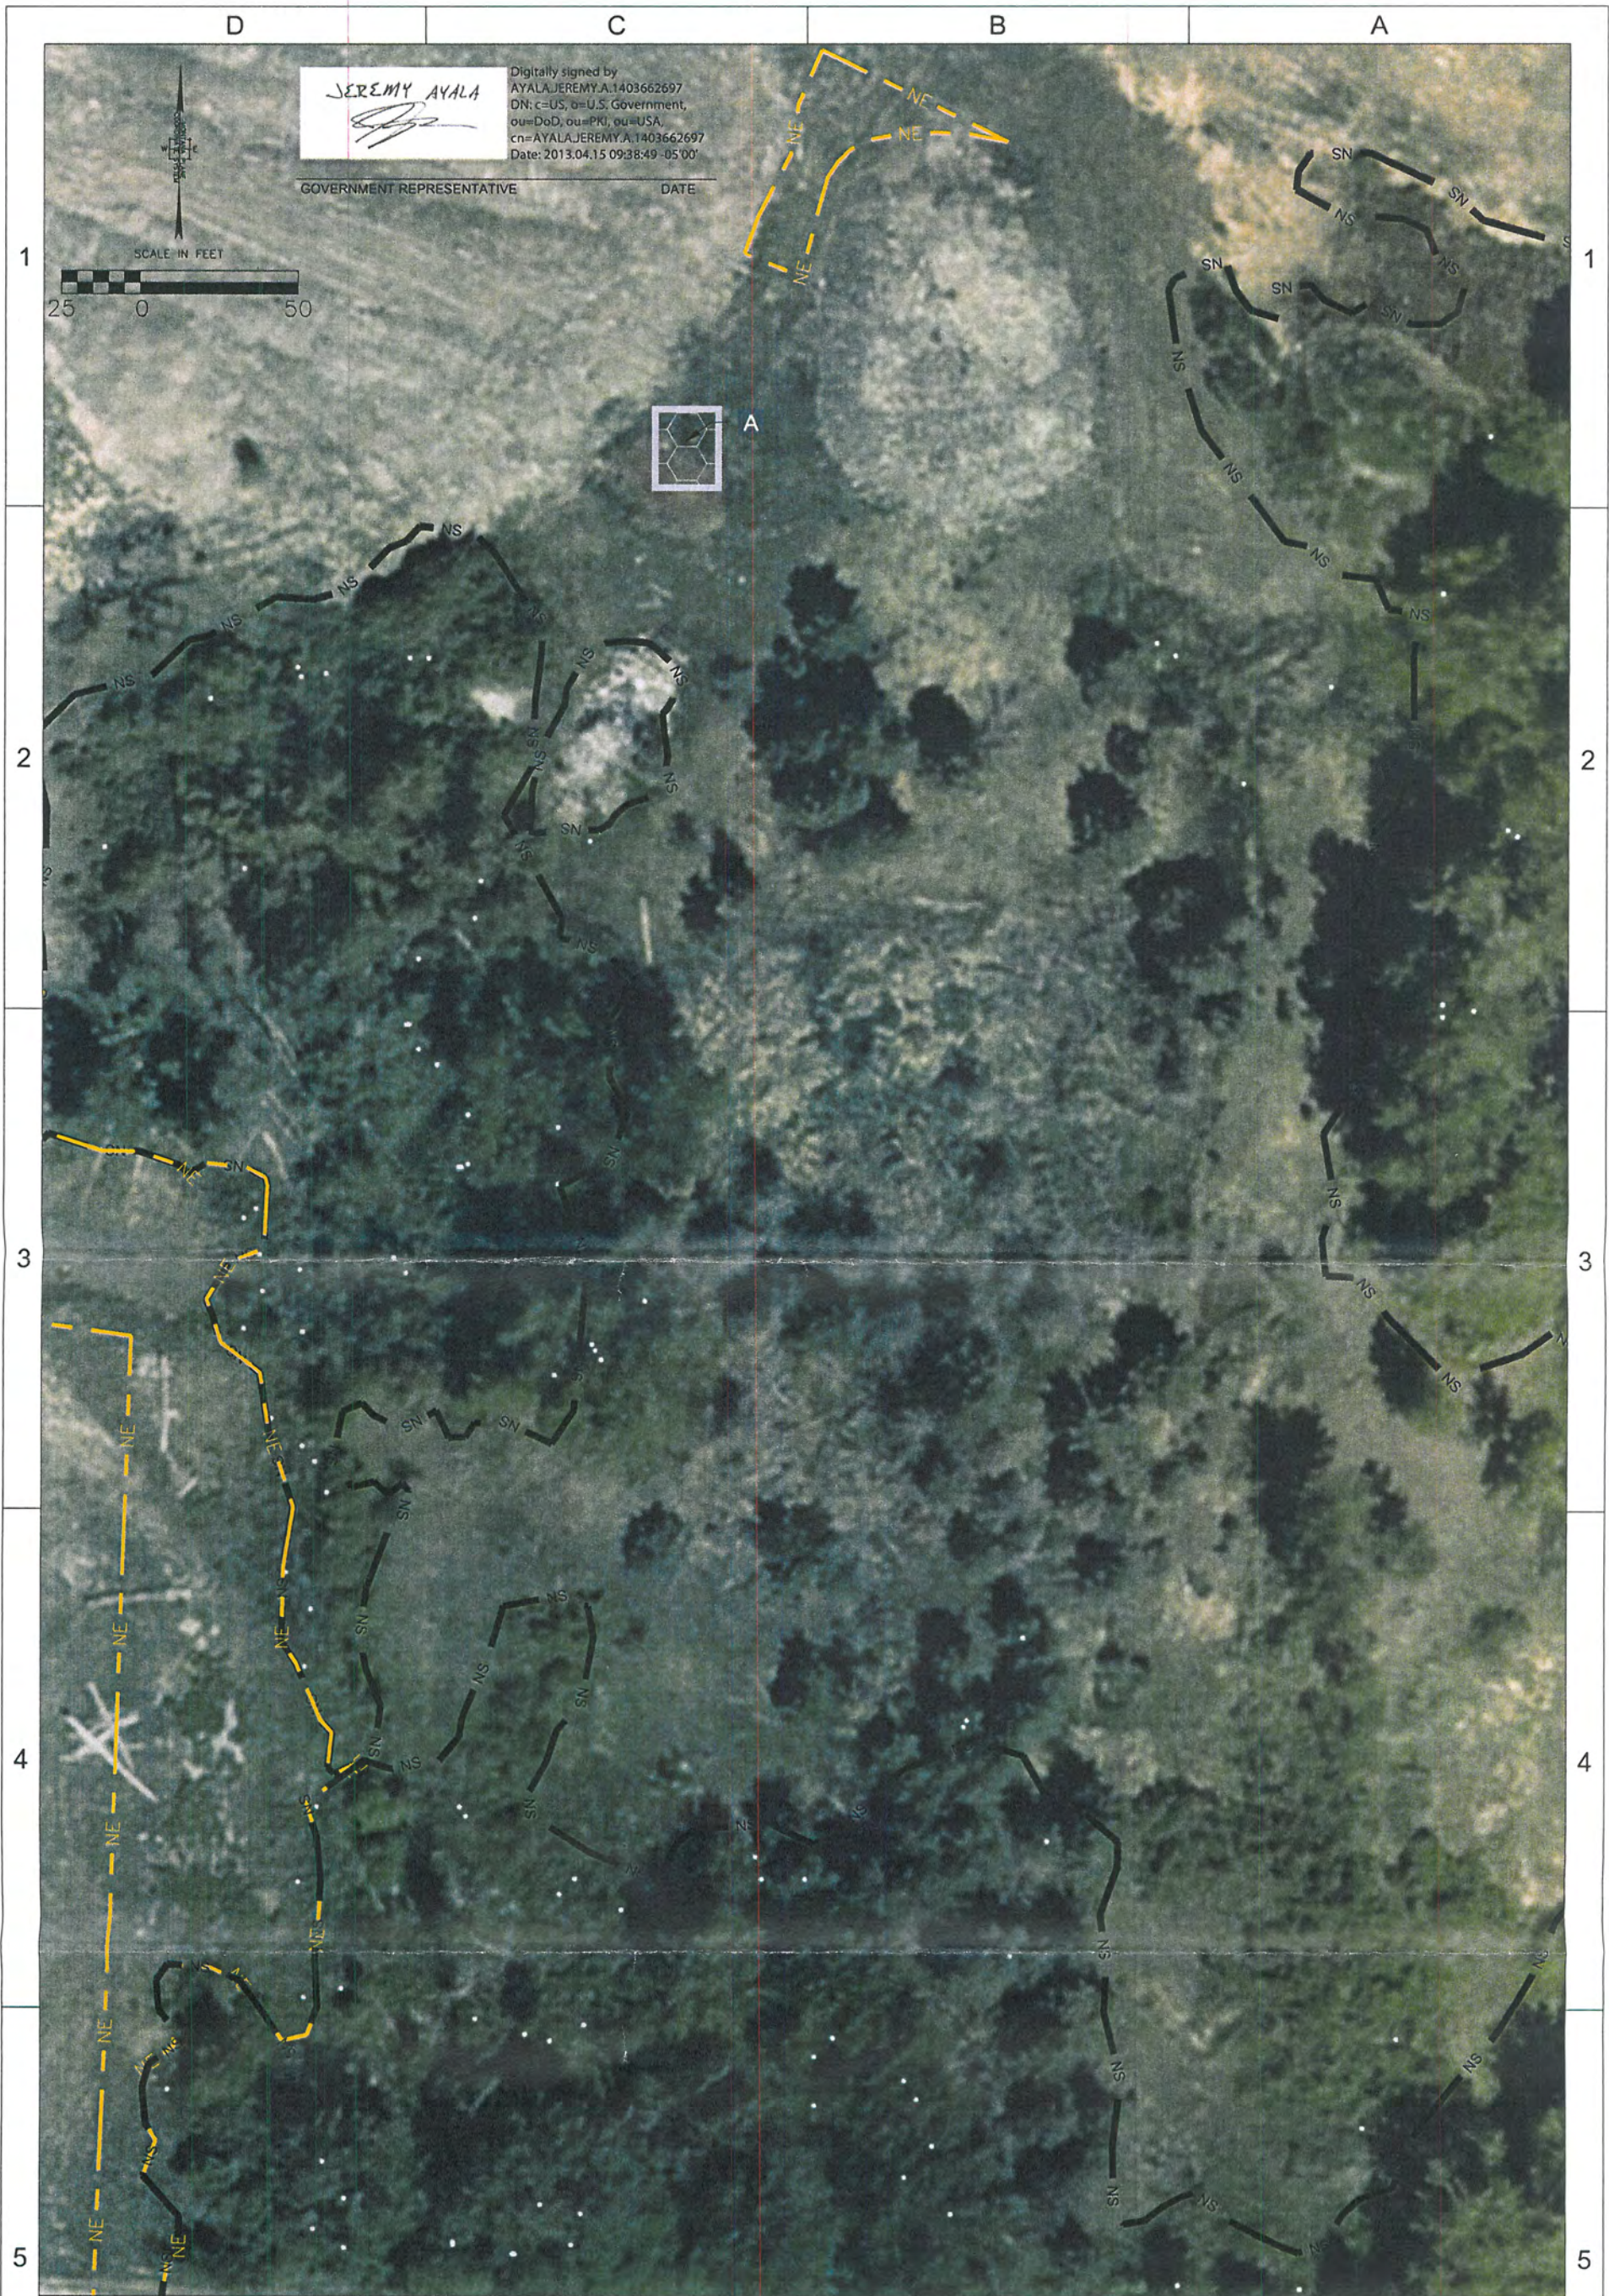
SHEET: 2 OF 2

Pile of building debris.  
No VCI observed.  
No sample taken.

BLACK LINE SHOWS PROPOSED SITE OF  
FISHING POND. THIS LINE DOES NOT  
COMPLETELY MATCH SITE CONDITIONS OF  
THE FLAGGING PUT OUT BY LINCOLN COUNTY

FORMER NUA SAMPLED ON 3-14-13.  
NO VCS OBSERVED. SP-146237, 7-00114 ND
